JD-87-GP07

CONTRACT NO: DAAK70-87-C-0061

FINAL REPORT

SDMHE DRIVELINE BENCHTEST

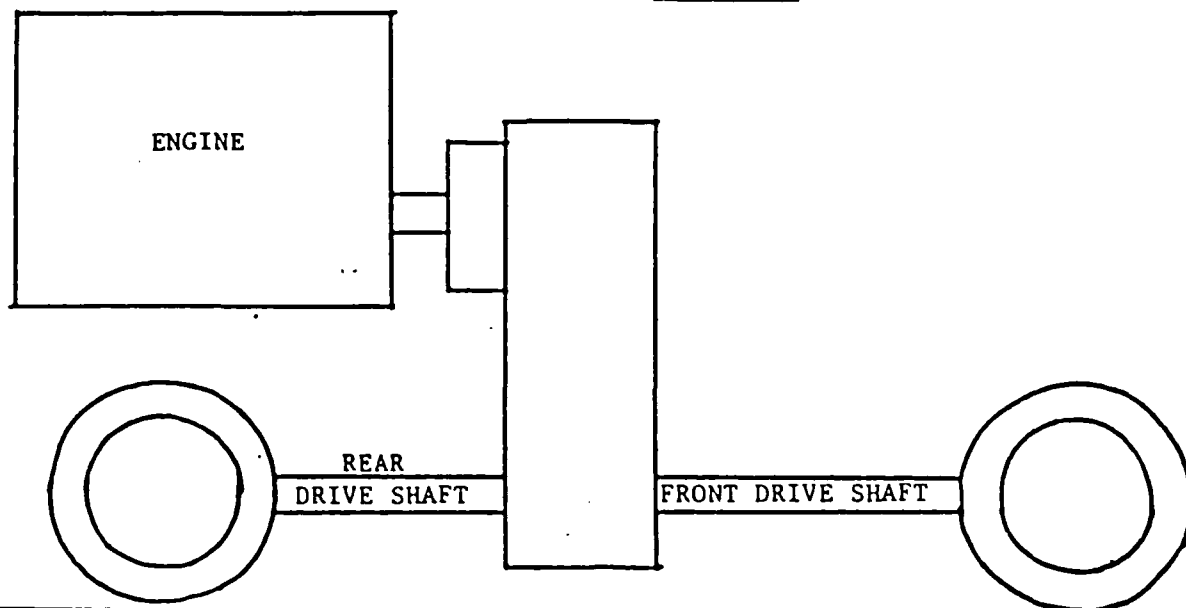
FIGURE 2: SCHEMATIC OF SDMHE POWERTRAIN IN LABORATORY TEST RIG

SIDE VIEW

TOP VIEW

The laboratory test rig was built to contain a complete set of selected driveline components in the basic configuration shown on Figure 2. For this high speed portion of the testing, the rear axle drive shaft was disconnected because the actual SDMHE vehicle will be equipped with a rear axle disconnect for high speed transport. This is necessary to prevent power loss and tire wear due to tire scrub interactions in gears 4-Forward through 6-Forward.

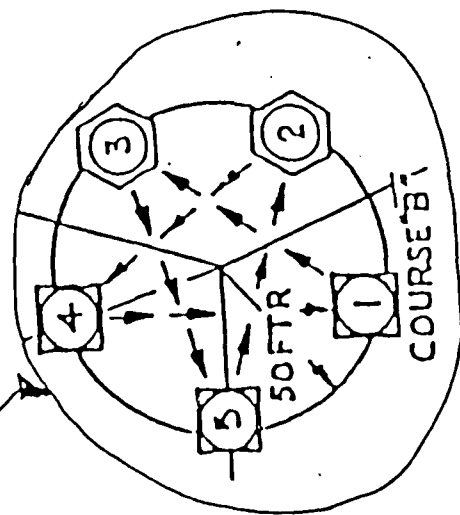
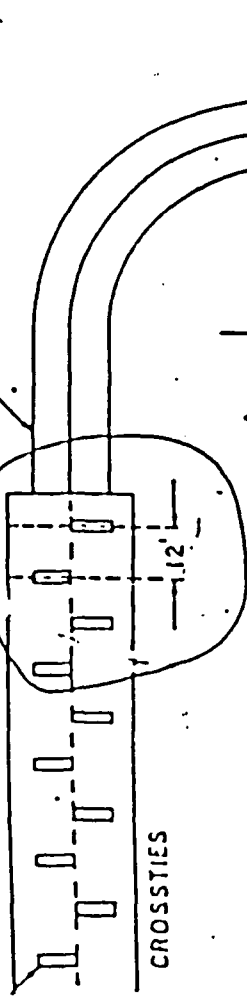
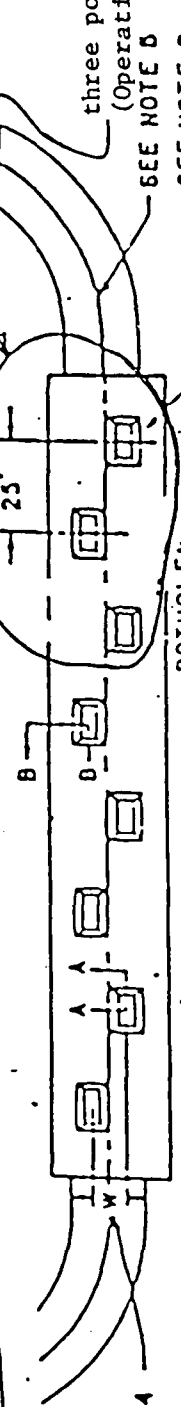
Course for Operation 1

four crossies (for Operation 6)

three potholes  
(Operation 7)

1. ELEVEN CROSSIES, 6' LONG, ANCHORED TO PREVENT MOVEMENT. CROSSIES SHALL BE 2" HIGH, 4" WIDE FOR FORKLIFTS UNDER 6000 LB CAPACITY, 6" BY 6" FOR FORKLIFTS OF 6000 LB. AND OVER CAPACITY.
2. EIGHT CONCRETE POTHoles 6' WIDE AND 8' LONG SUNK FLUSH WITH GROUND LEVEL.
3. STABILIZED SURFACE 15' WIDE MINIMUM, EACH END OF COURSE.
4. W WILL BE THE APPROXIMATE TREAD OF THE VEHICLE.
5. DISTANCE AROUND COURSE AT CENTERLINE IS 760 ± 30 FEET. THIS COURSE MAY BE CONSTRUCTED WITH CROSSIE AND POTHOLE SECTIONS IN LINE, END TO END WITH TURN AROUND AT EACH END, PROVIDED TOTAL DISTANCE TRAVELLED IN ONE CYCLE IS 750 ± 30 FEET.

Operation 7 was Material Transport through potholes. It was estimated (Table 1 on Page 4) that this operation mode will make up 5 percent of the SDMHE field life. For the field torque history, the proposed duty cycle was like that for Operation 6, except that the four crossties will be replaced with three potholes. Forward operation was in first gear.

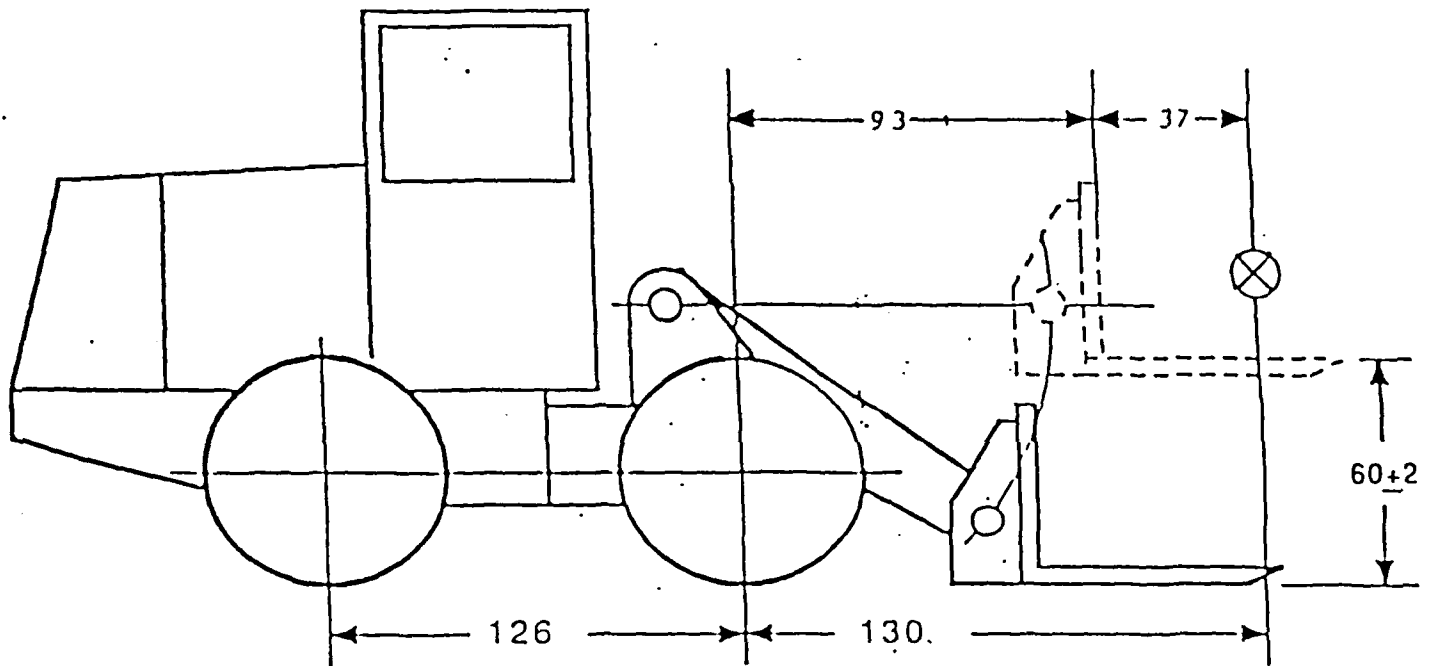
FIGURE 5

SDMHE Dimensions

Wheelbase	126 inches
Unloaded: (No weight on forks, fork at at 60 inch vertical height)	
Total Vehicle Weight	36,376 lbs.
Front Axle Weight	17,483 lbs.
Rear Axle Weight	18,893 lbs.
Loaded: (C.G. of 10,000 lb. weight is 37 inches forward of the fork heel, fork at 60 inch vertical height)	
Total Vehicle Weight	46,376 lbs.
Front Axle Weight	37,800 lbs.
Rear Axle Weight	8,576 lbs.

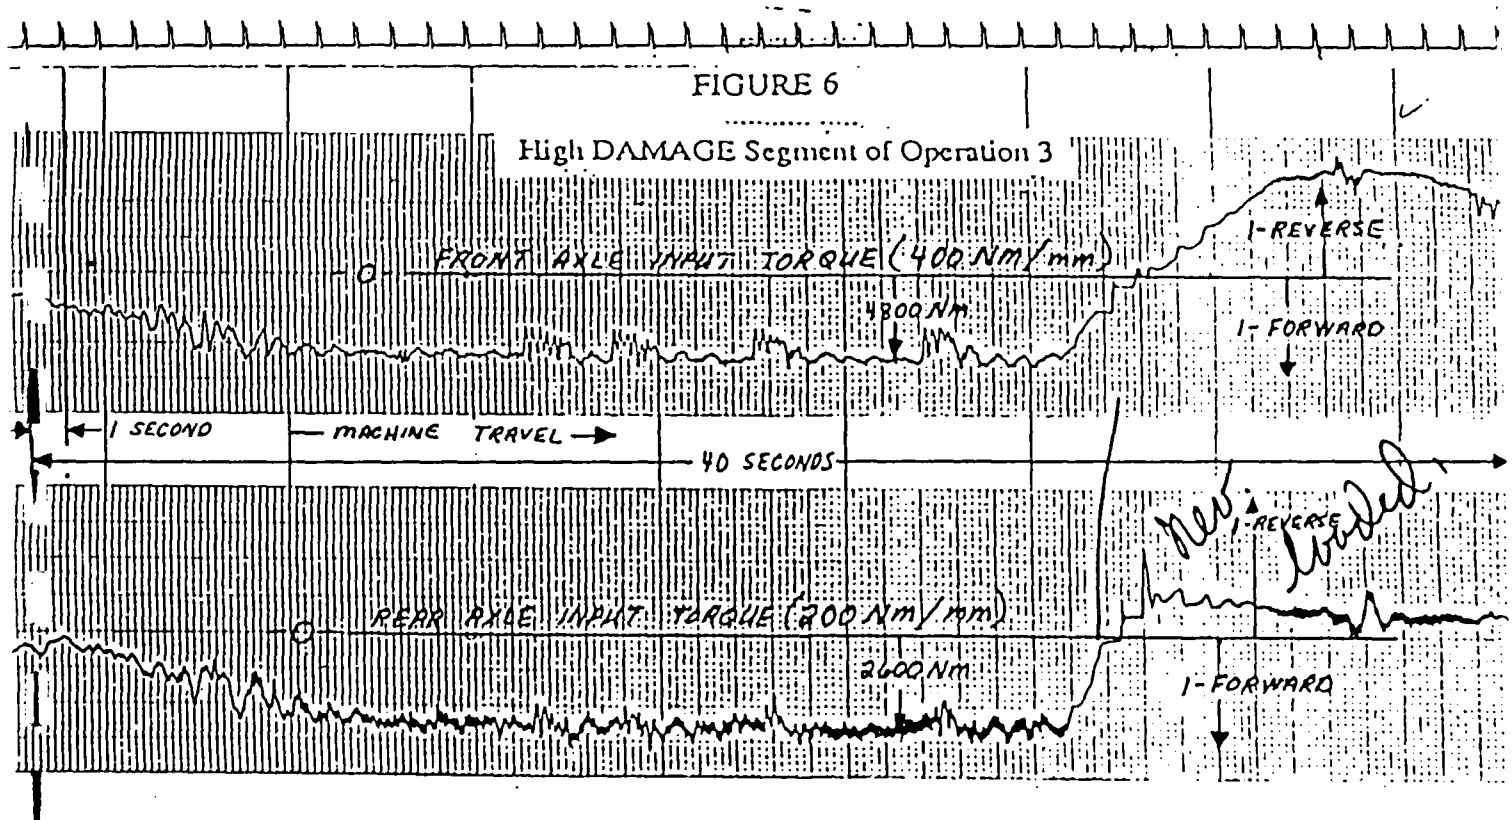
and back out was a 40 second segment of the 353 second data collection time used to compile the histogram for Operation 3. Figure 6 shows the recording made by pen recorder of front axle input shaft torque and rear axle input shaft torque during this 40 second segment.

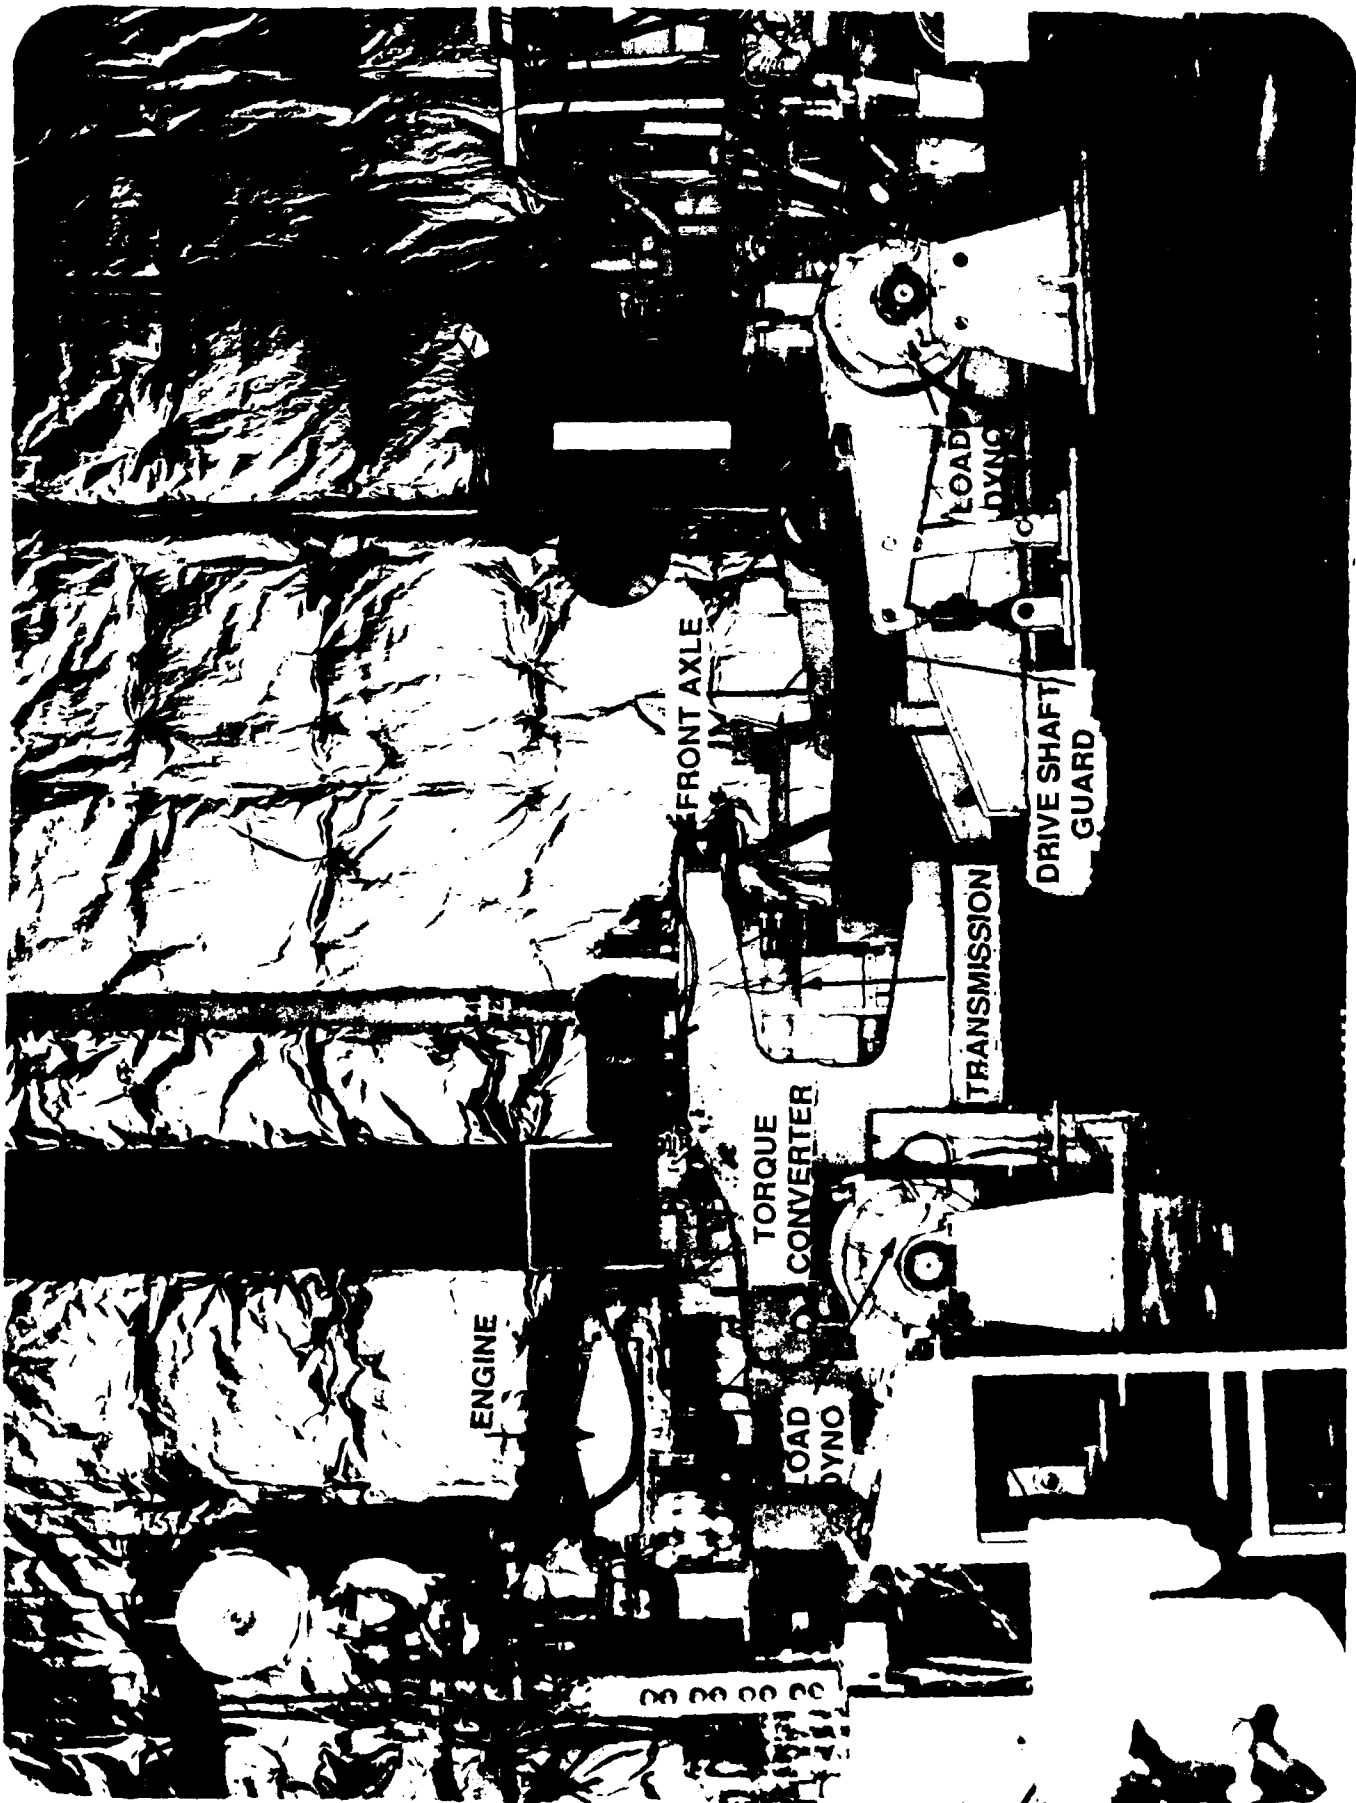
PHOTOGRAPH 1

Actual Laboratory Test Rig

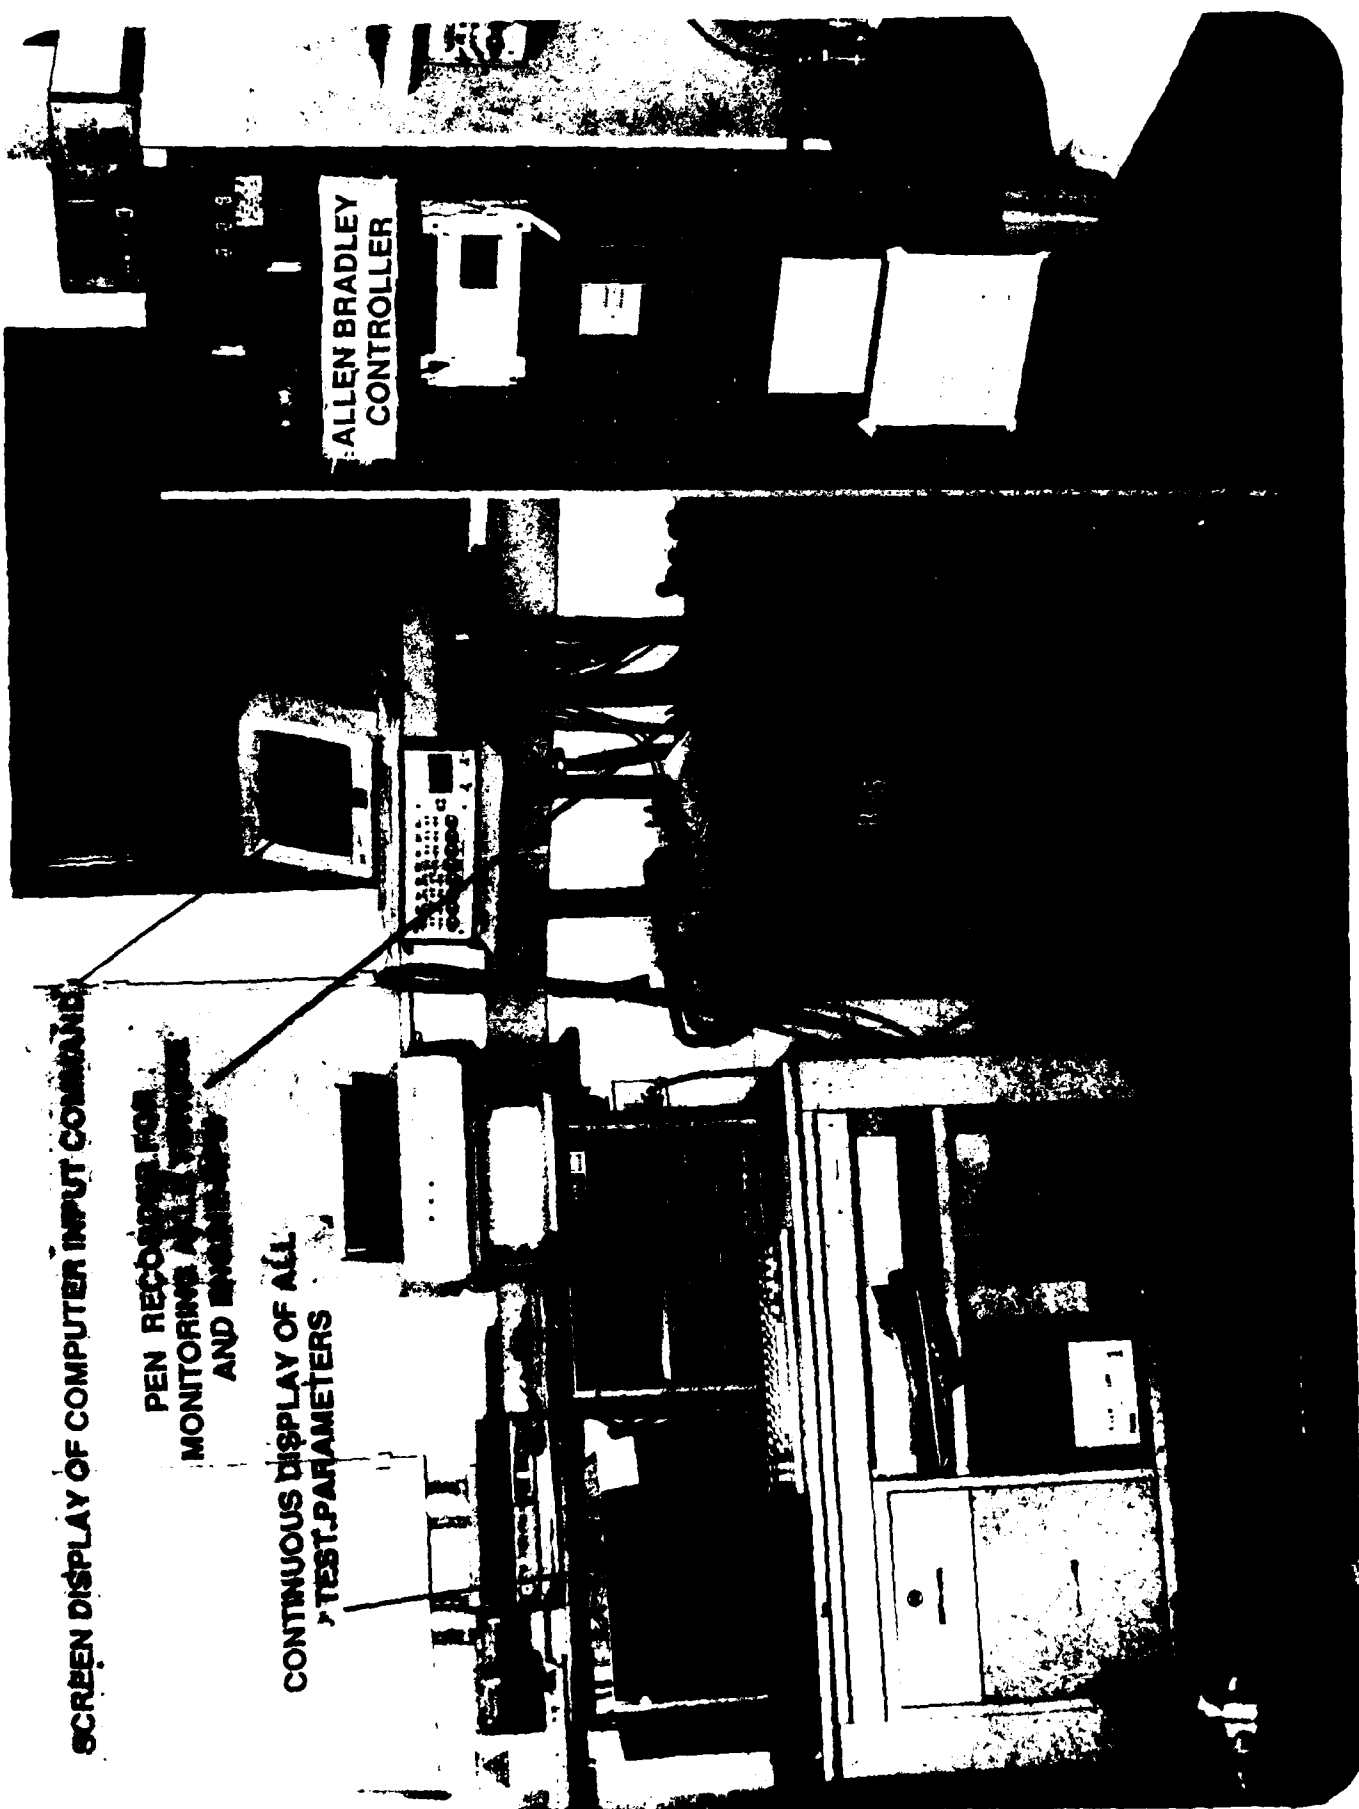
PHOTOGRAPH 2

ALLEN BRADLEY  
CONTROLLER

Laboratory Test Control Room

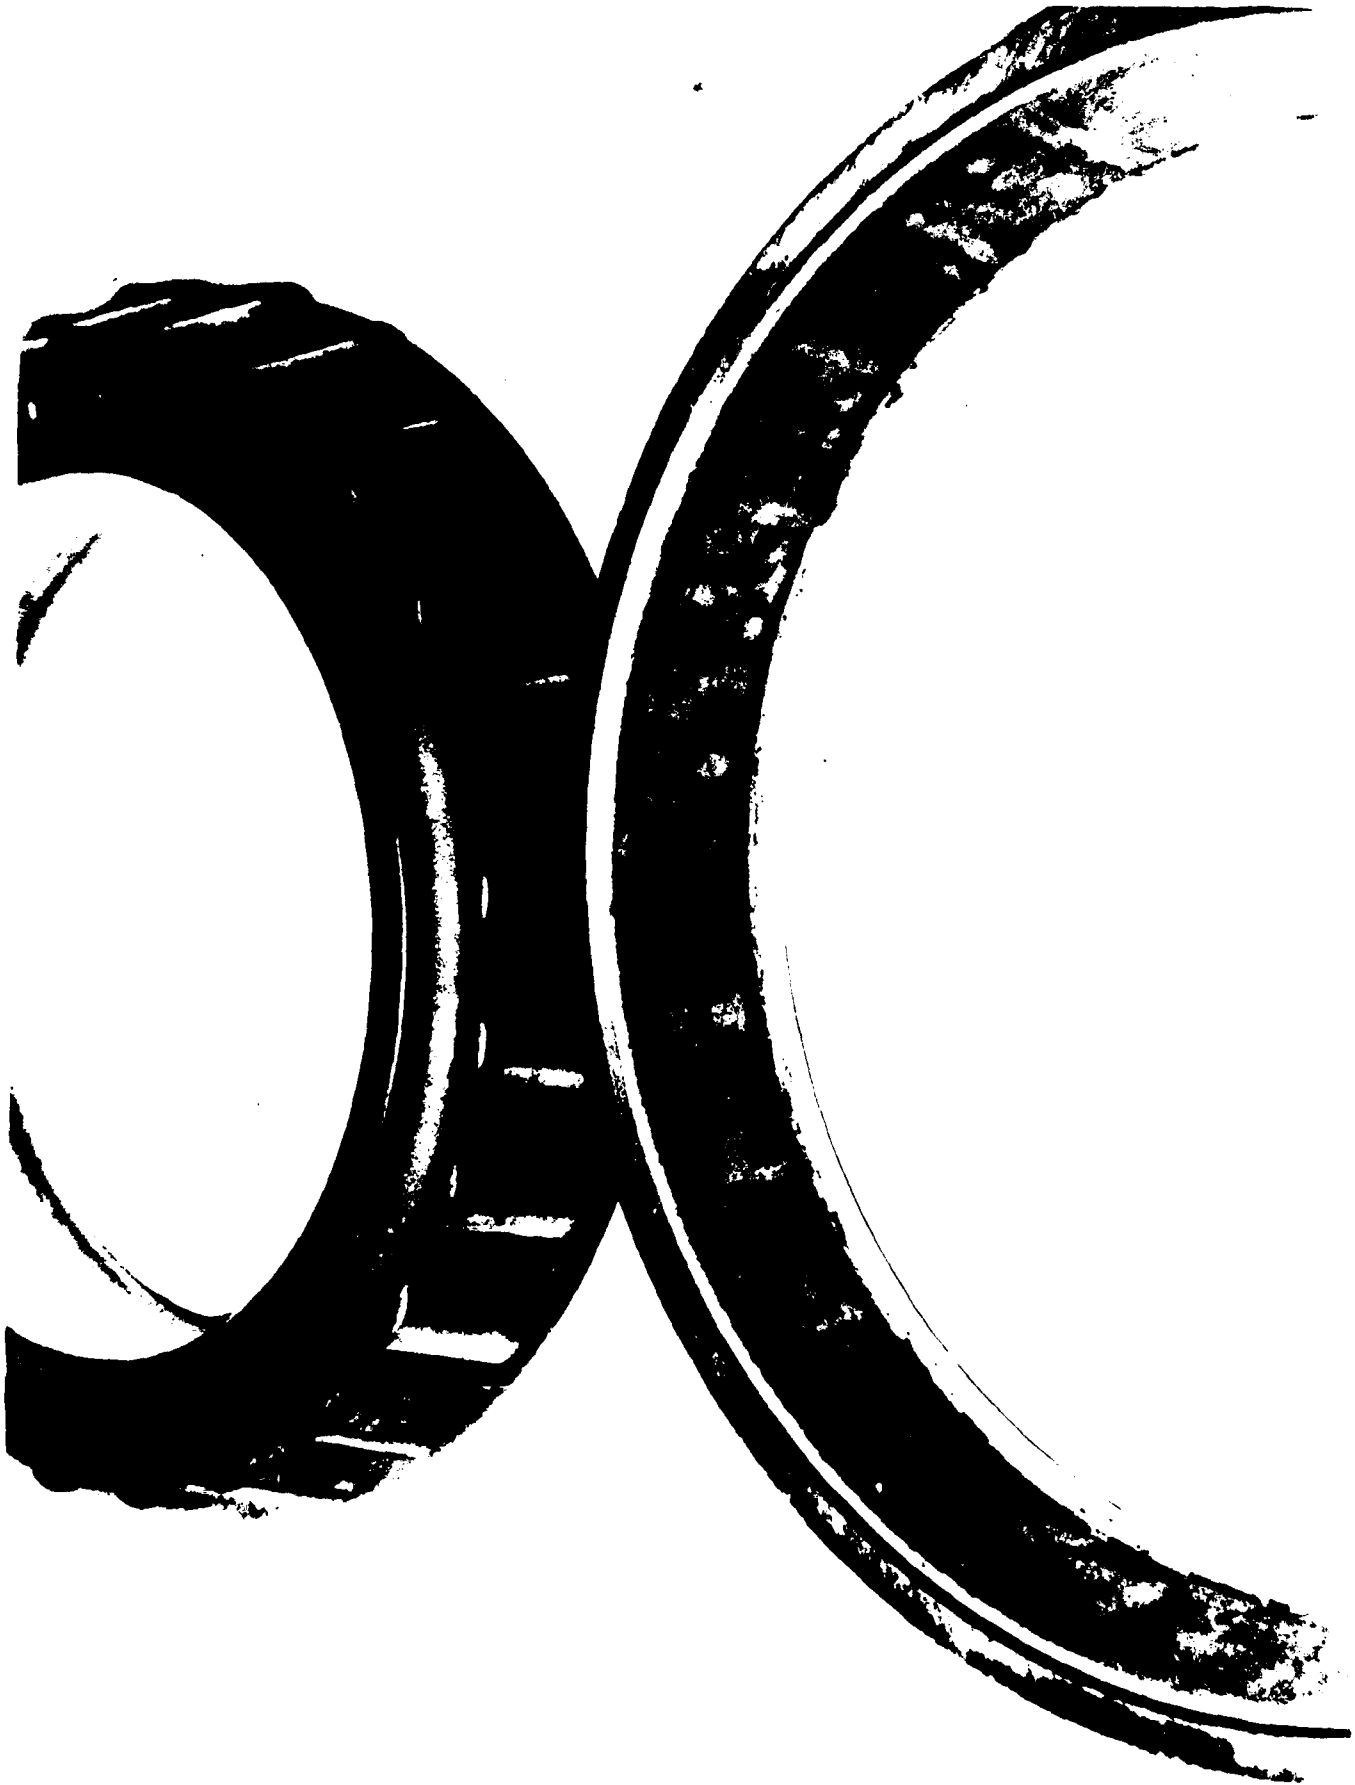
Replaced Bearings from LH Planetary - Front Axle

Rockwell International provided a new replacement planetary assembly for the LH side which included the planet gear spider, planet pinions, sun pinion, and planet pinion shafts. New planet pinion shafts were provided for the RH side (Photograph 5). The tapered roller bearings were also replaced on both sides as a precaution. The parts replaced are those "circled" on Table 6. Photographs 6 through 10 show other heat distressed parts, which were replaced.

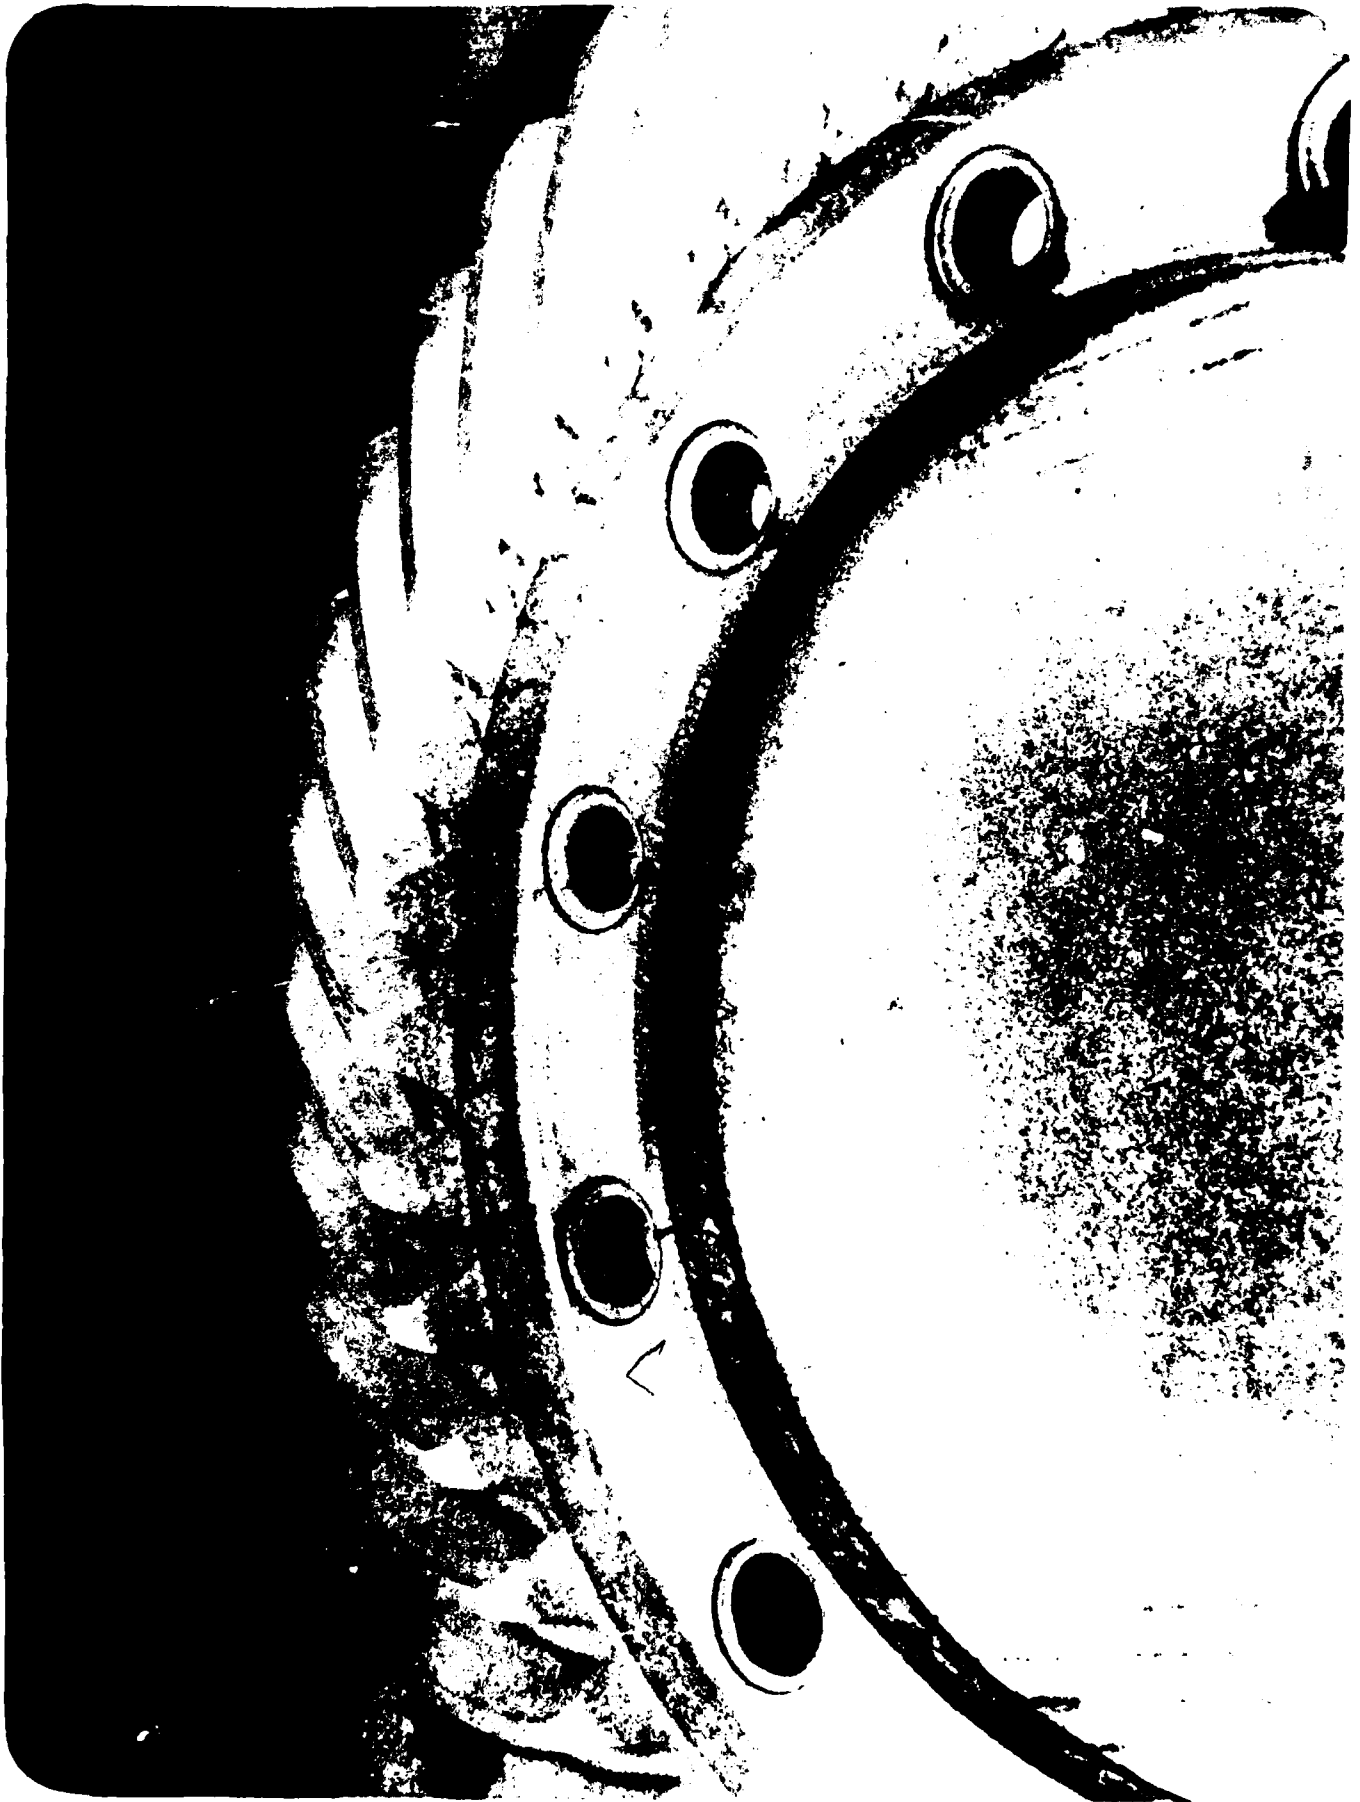
Fatigue Cracks on First Ring Gear Failure

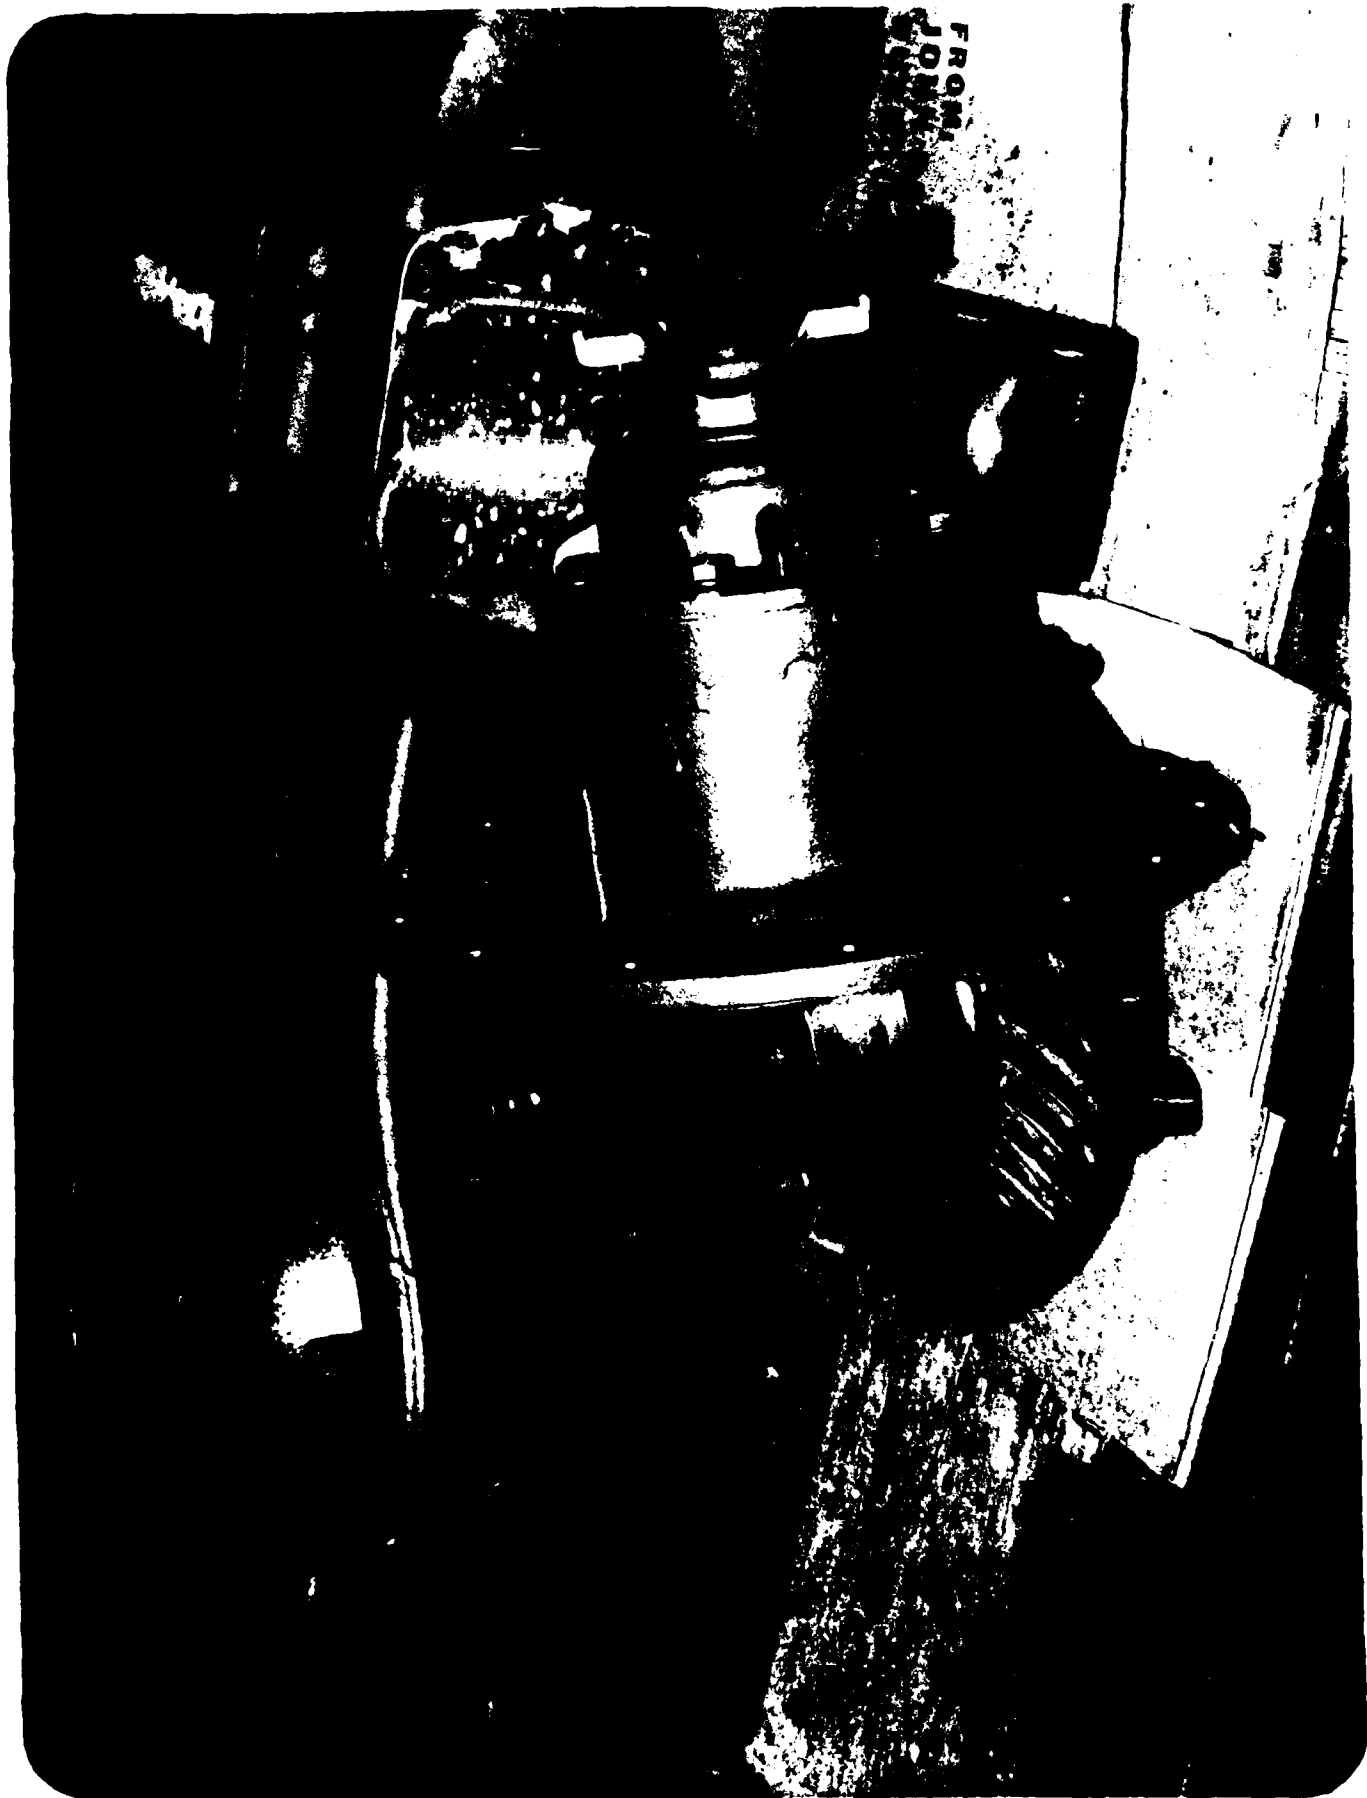
Differential Carrier Assembly

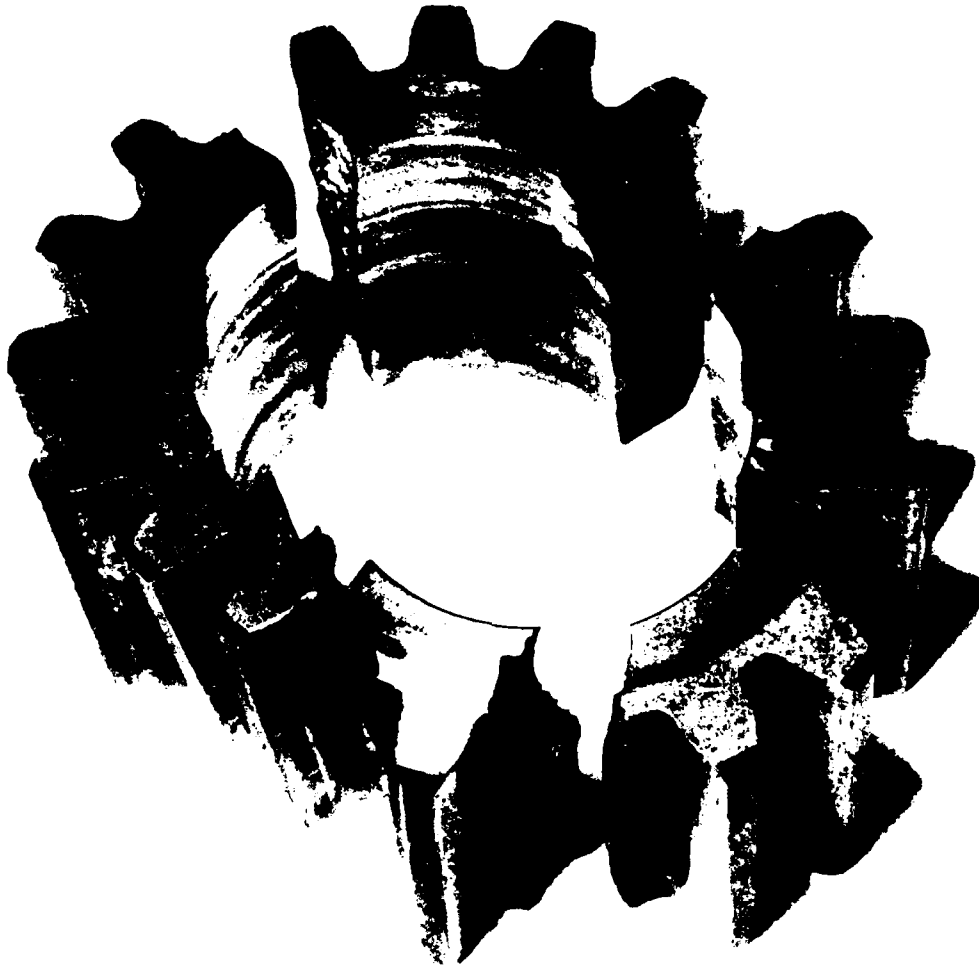
**Suspected Primary Failure Planetary Pinion**

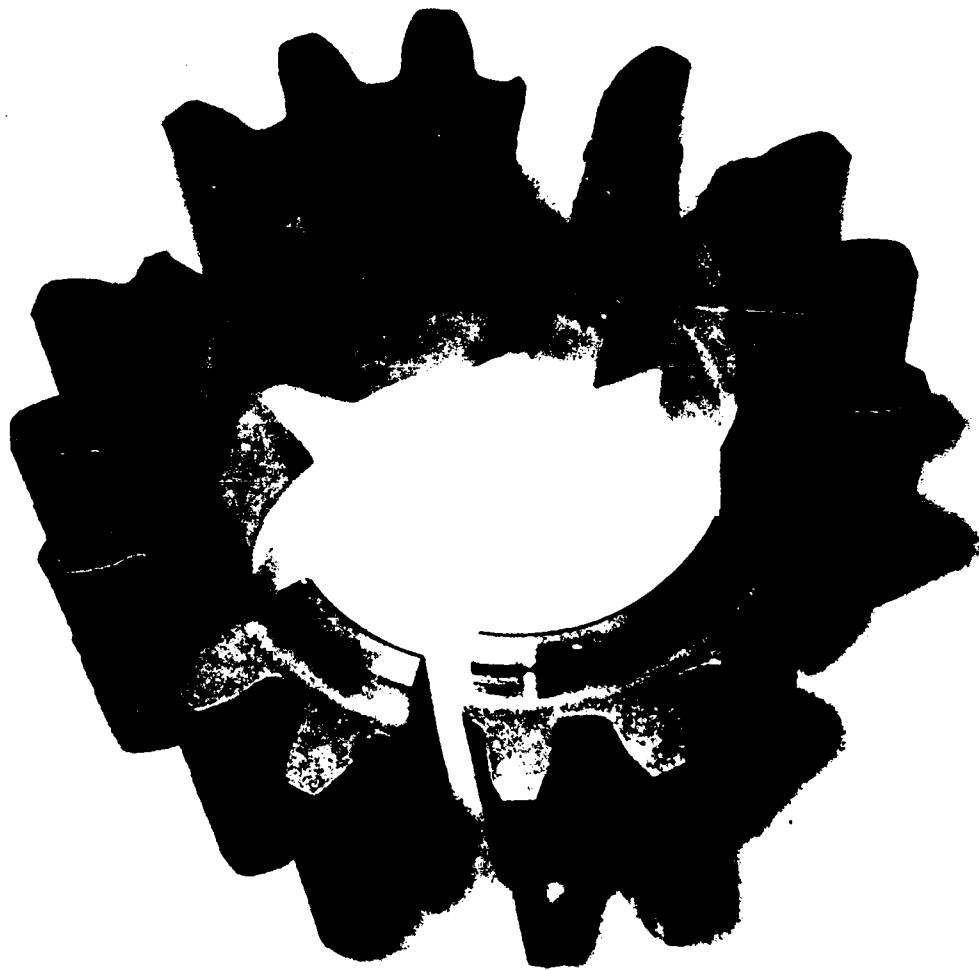
**Second Planetary Pinion w/Secondary Damage**

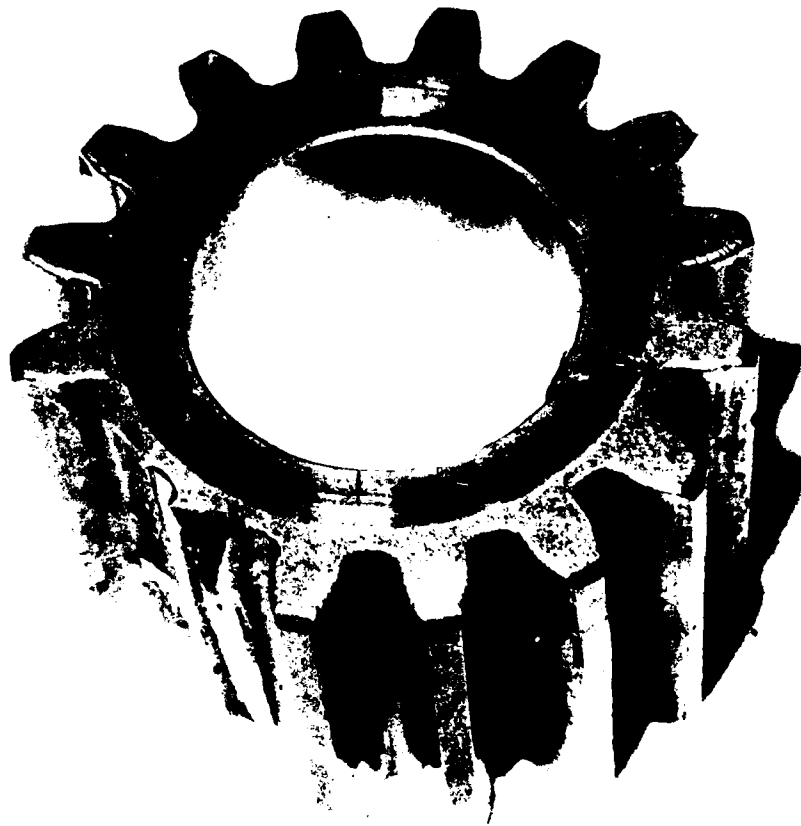
Thlrd Planetary Plnion w/Secondary Damage

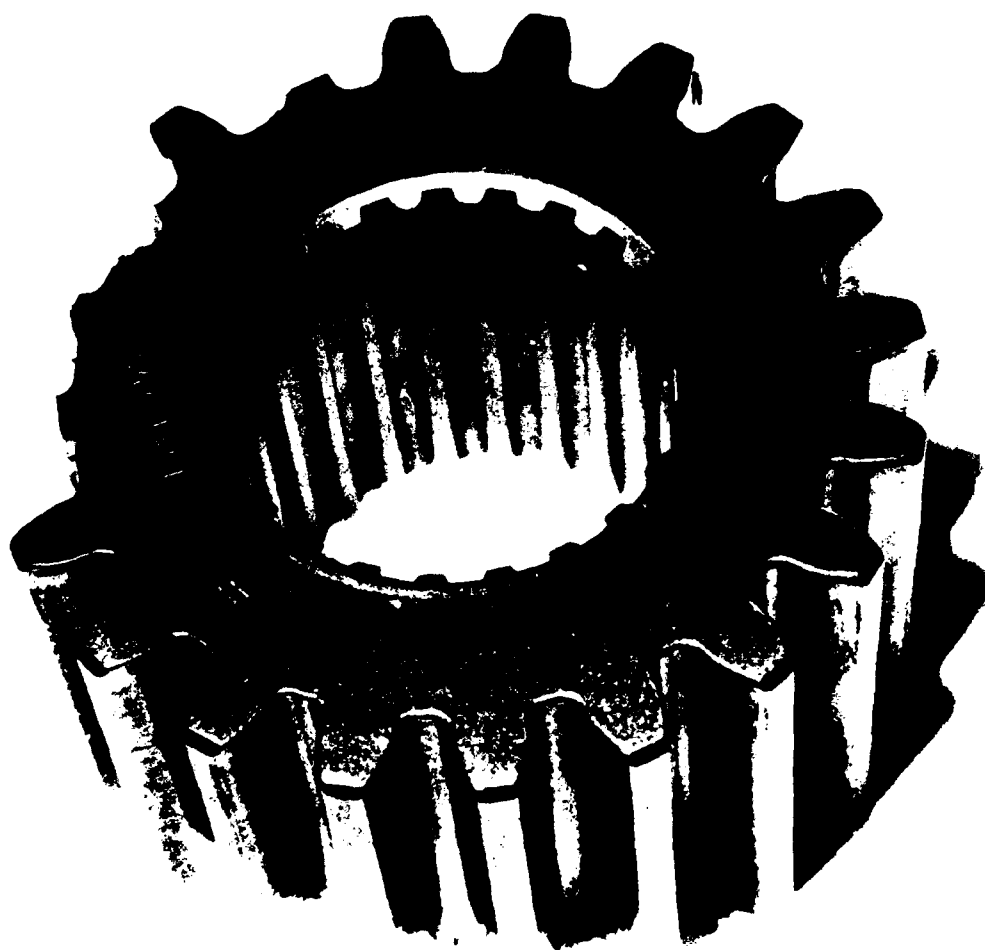
Sun Pinion w/Secondary Damagae

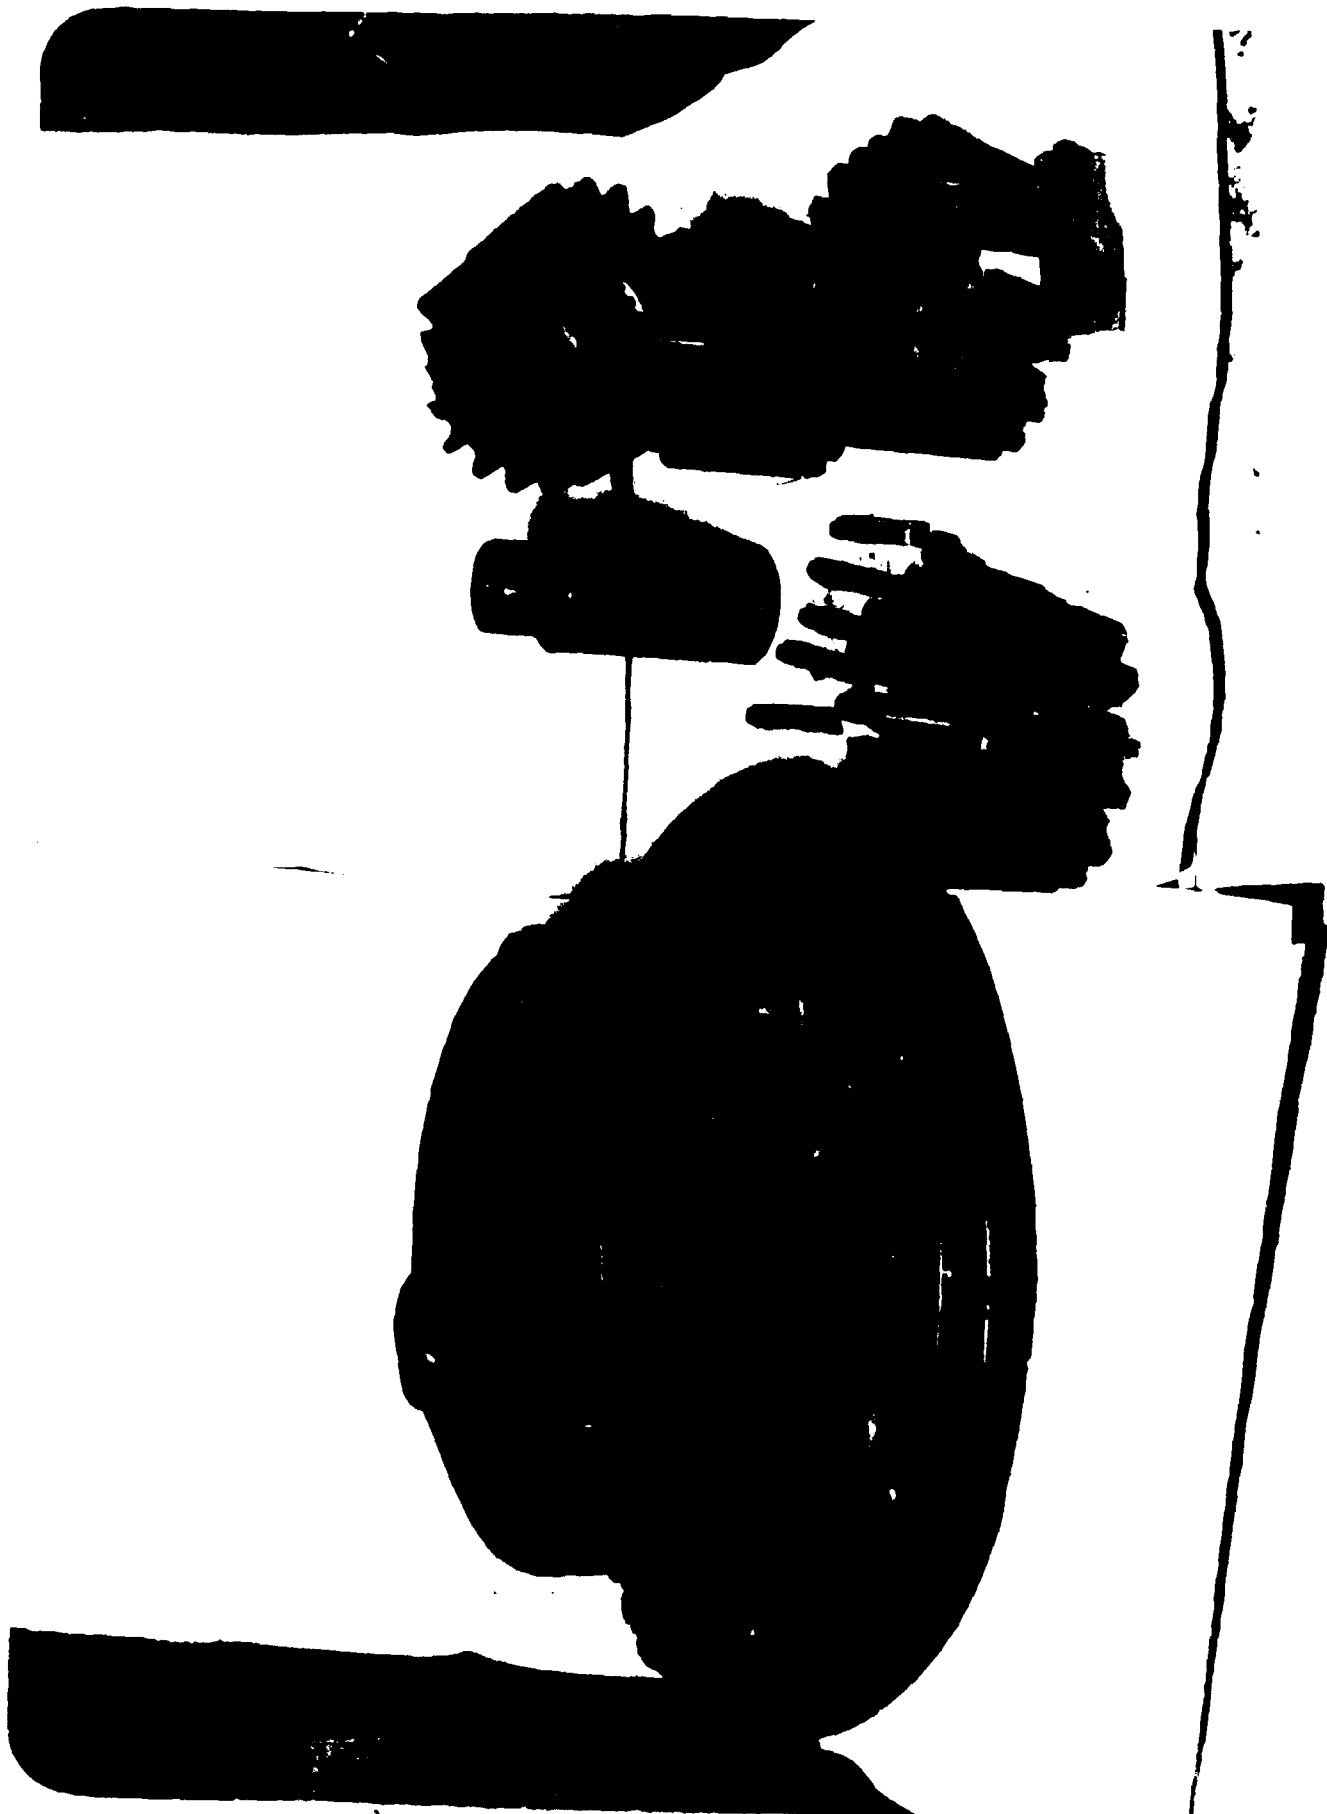
Failed RH Planetary of Front Axle
